# **Belfast Harbour, Belfast**

## **Desktop Study & Preliminary Risk Assessment**

Project No: A112794-67

August 21<sup>st</sup>, 2020

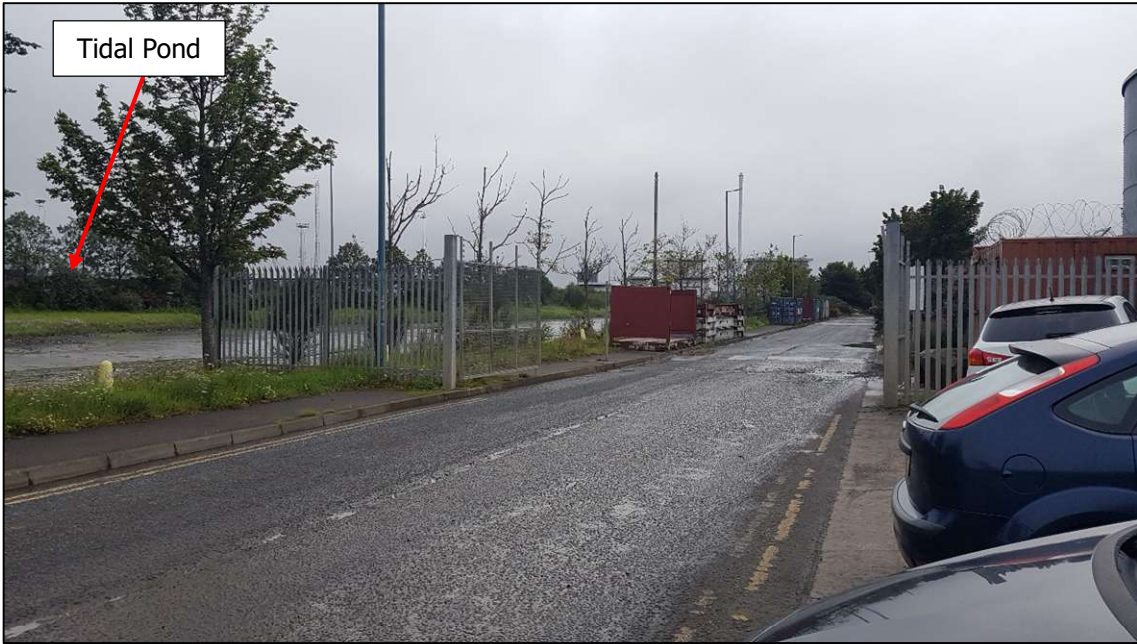
View of the entrance to the site.

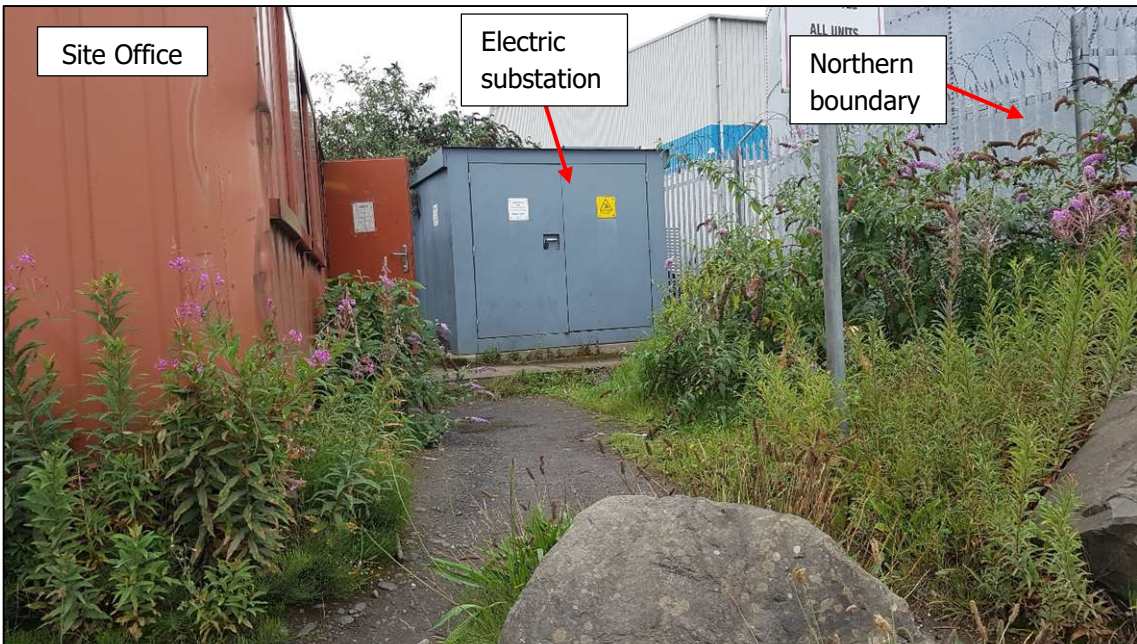
An electric substation was noted in the north eastern corner of the site. The age of the substation is unknown and as such there is the potential for PCB (Polychlorinated Biphenyls) contamination to have occurred historically, however it appeared to be in good condition. PCBs are generally low mobility, low volatility contaminants and as such are persistent in the environment.

View of the electric substation located in the northern eastern corner of the site, adjacent to the northern boundary.

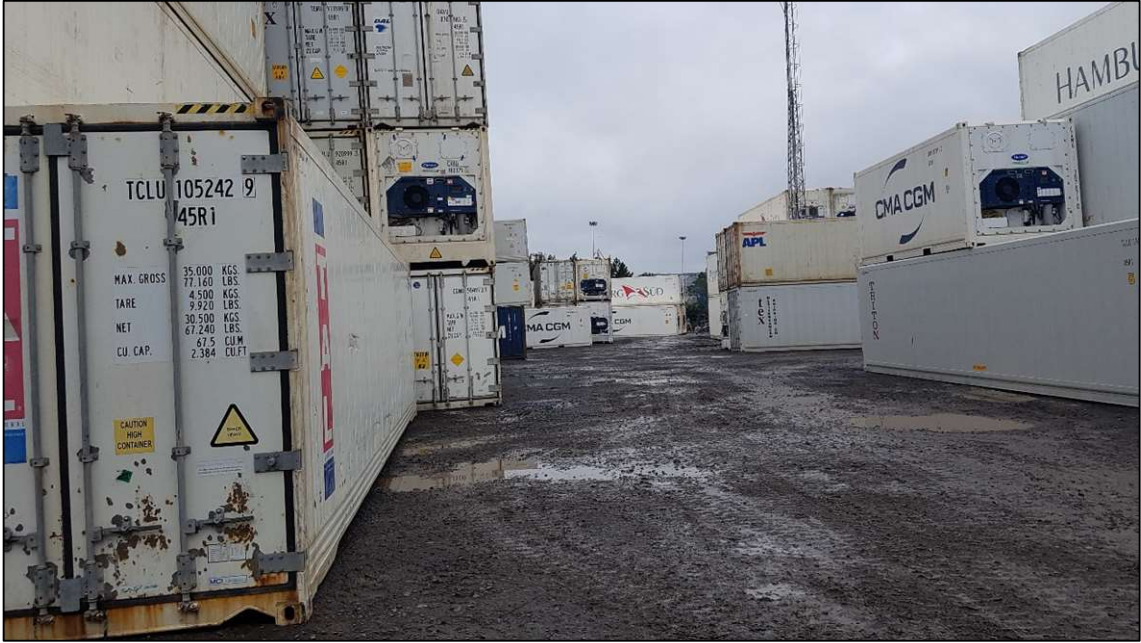
View of the shipping containers currently stored at the site.

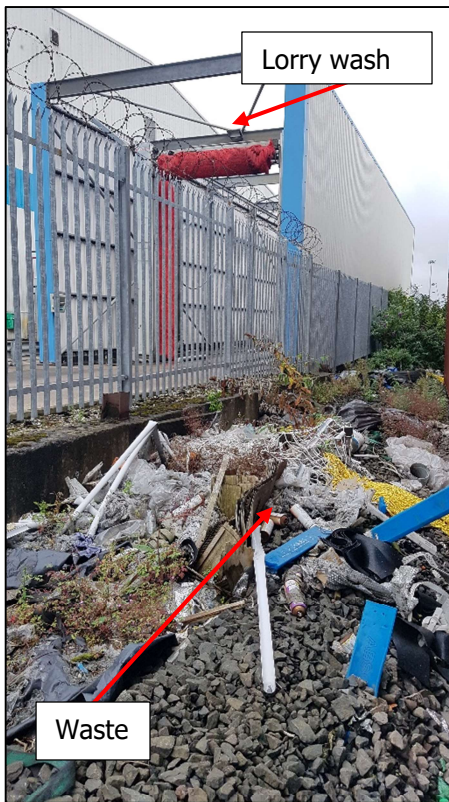
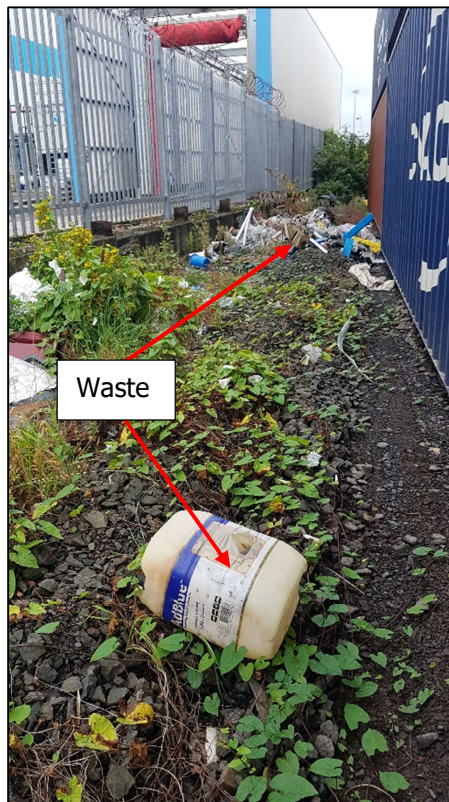
View of the lorry wash located on the adjacent site, close to the northern boundary. Dumping of plastics, aerosols and wood were noted along the northern boundary.

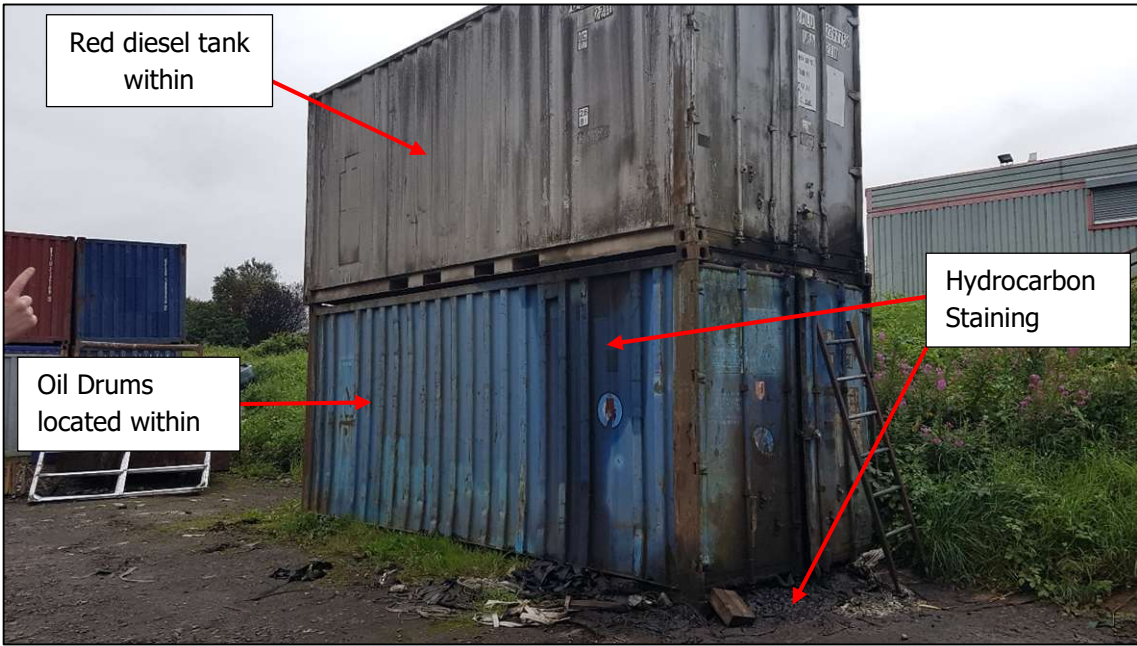
Aspect	Description
Evidence of tanks currently on-site	<p>It was reported that a plastic above ground storage tank (AST) containing red diesel is located in an elevated shipping container along the western side of the site. The container was not assessable during the site walkover. It was reported that pipe work is attached to the tank and the onsite fork lifts are refuelled via gravity feed.</p> <p>2no. oil drums containing lubricant oil are stored within the lower shipping container.</p> <p>A disused plastic AST was noted along the western boundary. It was reported that it has previously been used to store diesel.</p>
Evidence of chemical Storage	<p>Small amounts of paints, white spirits and other cleaning agents were noted along the eastern side of the site in the area where repairs and maintenance of the containers are undertaken. Welding material are also stored here used to repair containers.</p>

View of two containers located along the western boundary

Where AST`s are considered for offsite removal the following provides an outline of works recommended to be undertaken in line with PPG2 guidance document Above Ground Storage Tanks PPG2.

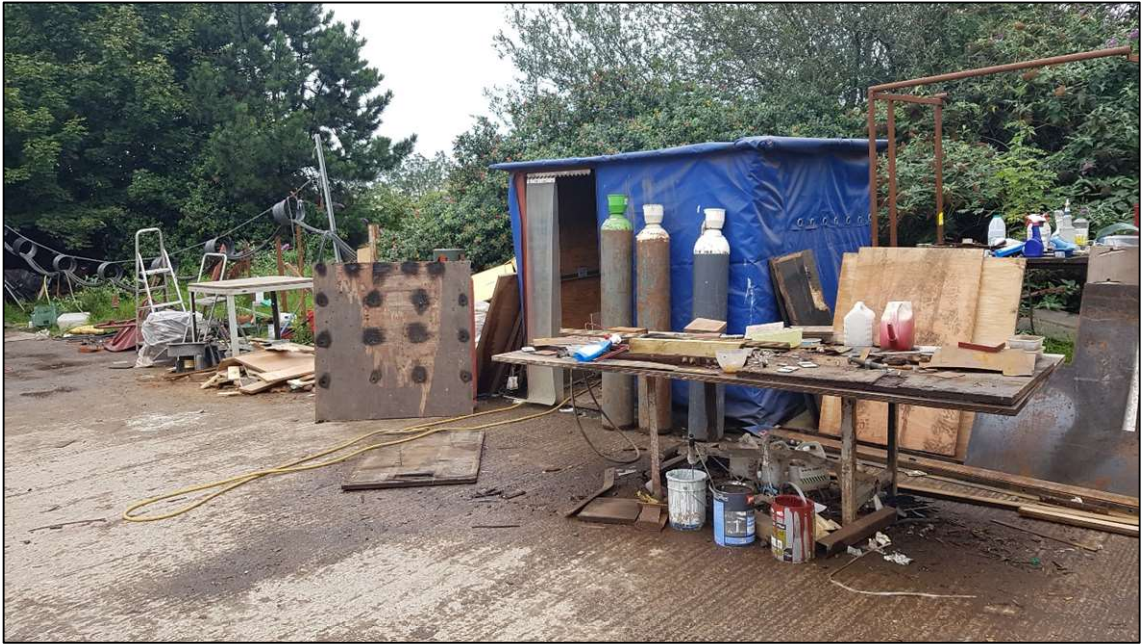
It is anticipated that there is the potential for spills and leaks to have resulted from the storage of fuels, oils and paints, associated with current site use potentially impacting shallow soils and groundwater.

View of paints and white spirits stored along the western boundary of the site.
