Larne Harbour, Larne

Desktop Study & Preliminary Risk Assessment

Project No: A112794-67

DAERA

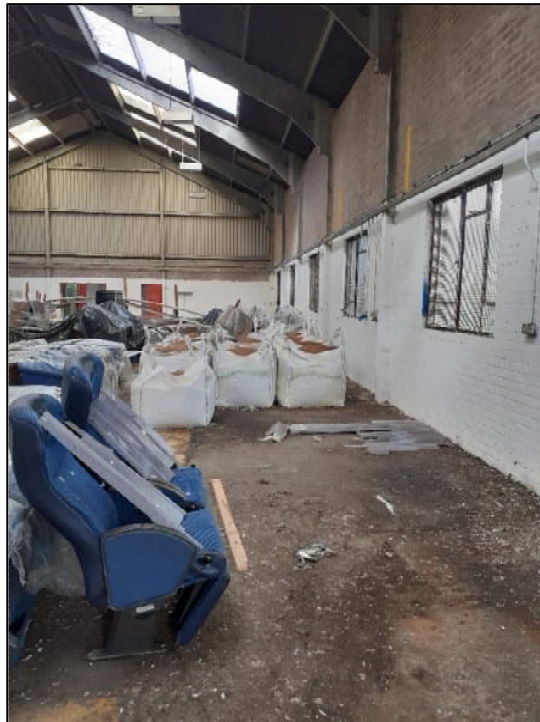
Staining was also noted on the concrete floor of the former lorry repairs garage to the east.

View inside the former garage, now used for storage with oil staining remaining on the concrete floor.

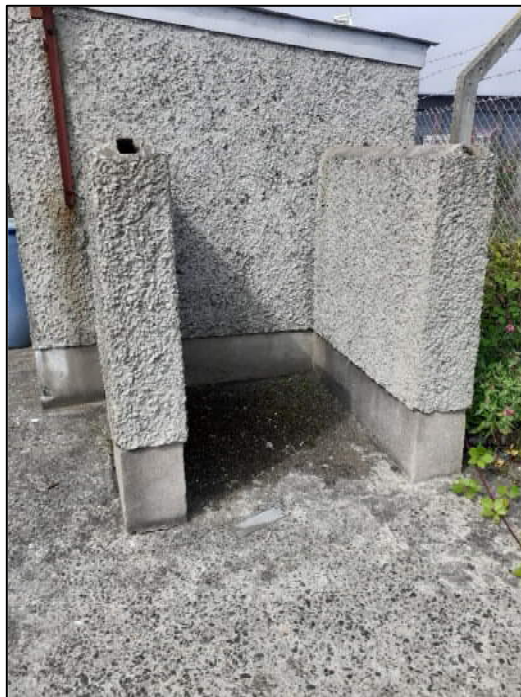
External possible tank location adjoining the pump house to the east of the former garage, with the vehicle inspection ramp to the south.

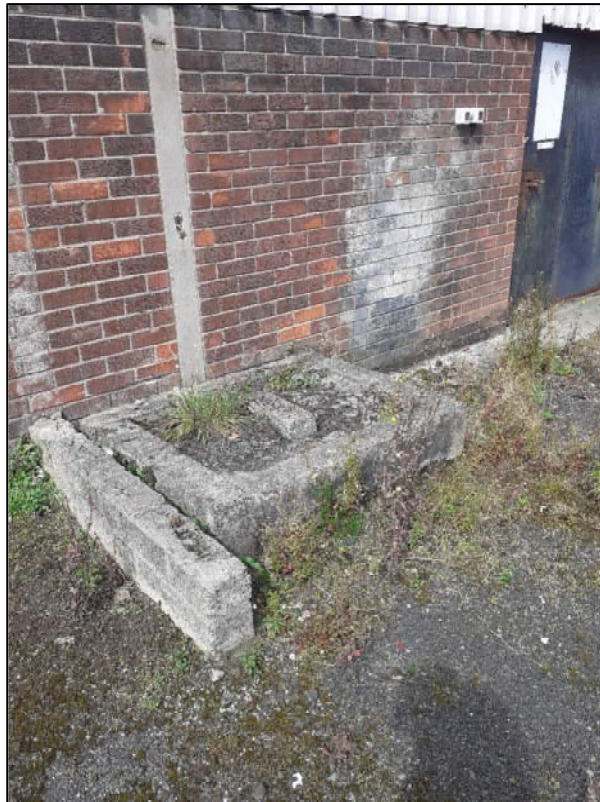
View of the remains of a brick base that may have housed a tank or boiler house.

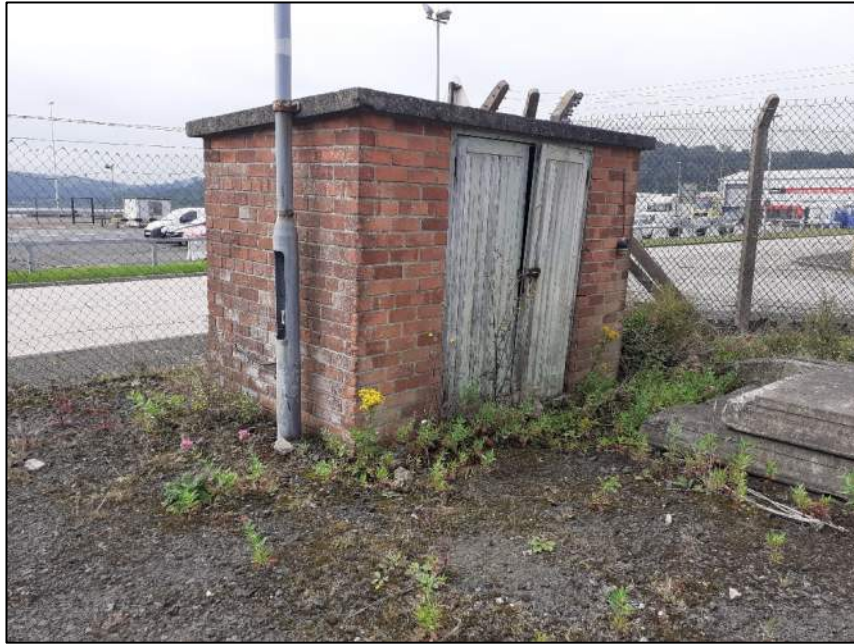
View of former electrical sub-station (ESS), now decommissioned, at the southern boundary, adjacent to the DAERA site boundary.

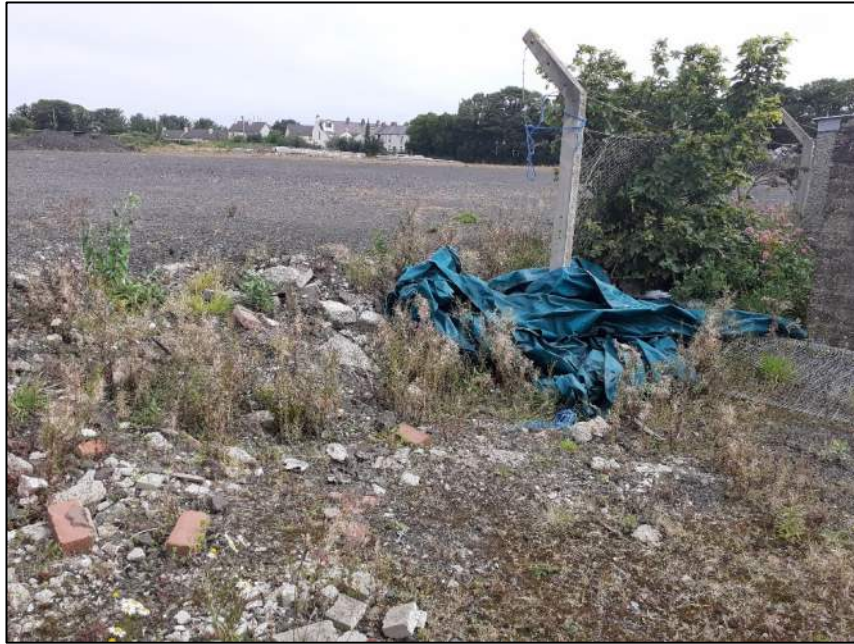
View of the rise in level from the southern section of the site to the mid site area and demolition wastes present.

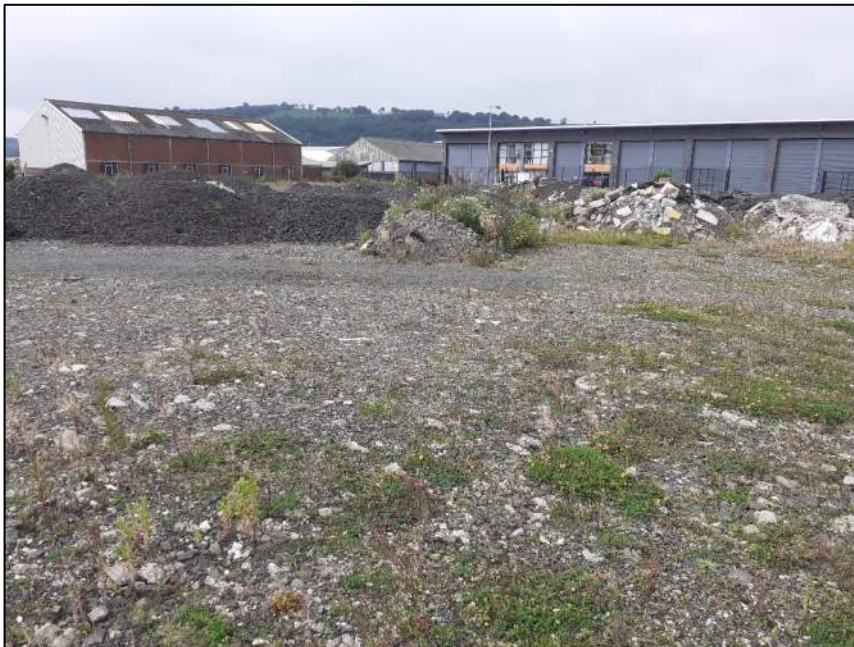
View of the stockpiles of gravel and demolition rubble at the western site boundary.

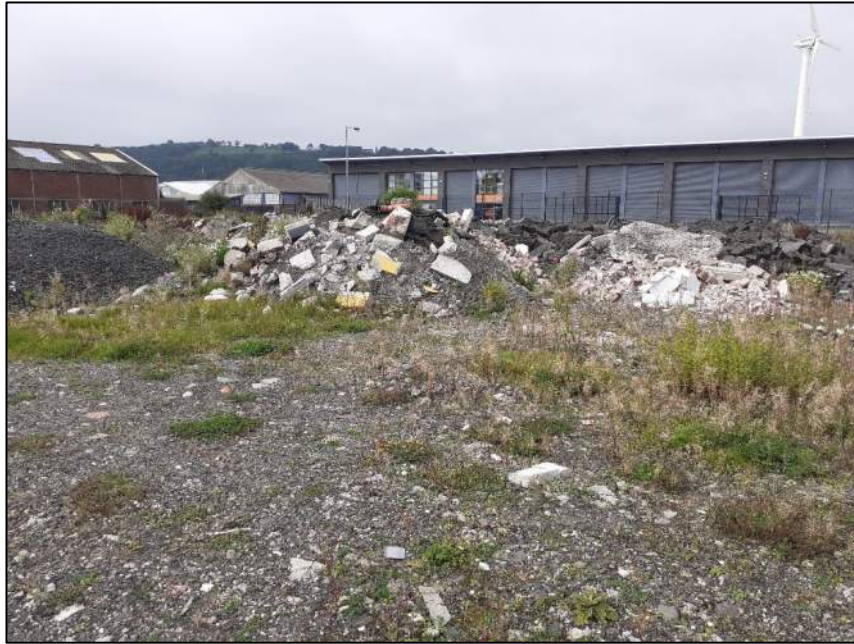
View of the demolition rubble stockpiles.

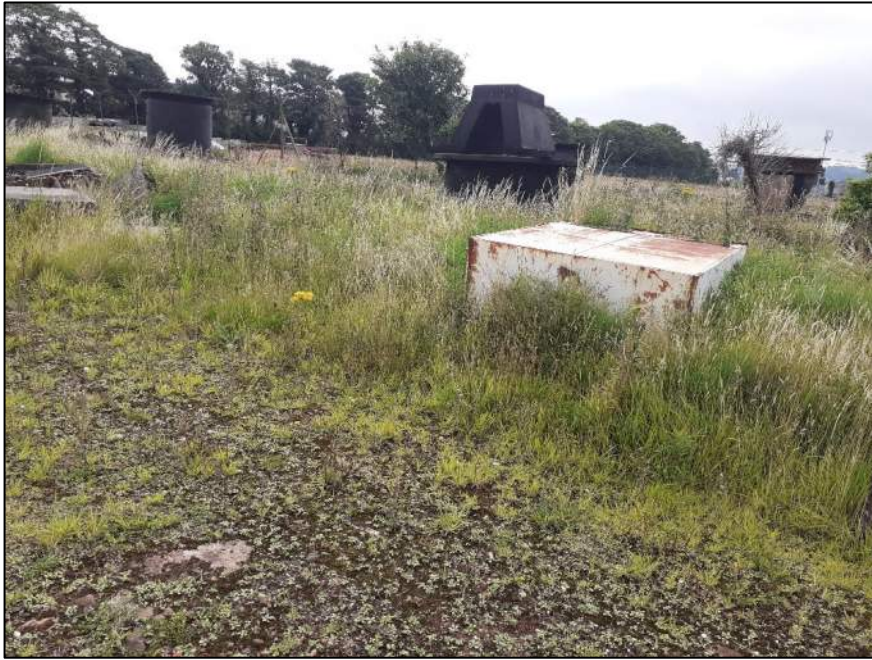
View of old empty rusted metal oil tank with fenders to the rear in the northern area of the site.

Where AST`s are considered for offsite removal the following provides an outline of works recommended to be undertaken in line with PPG2 guidance document Above Ground Storage Tanks PPG2.

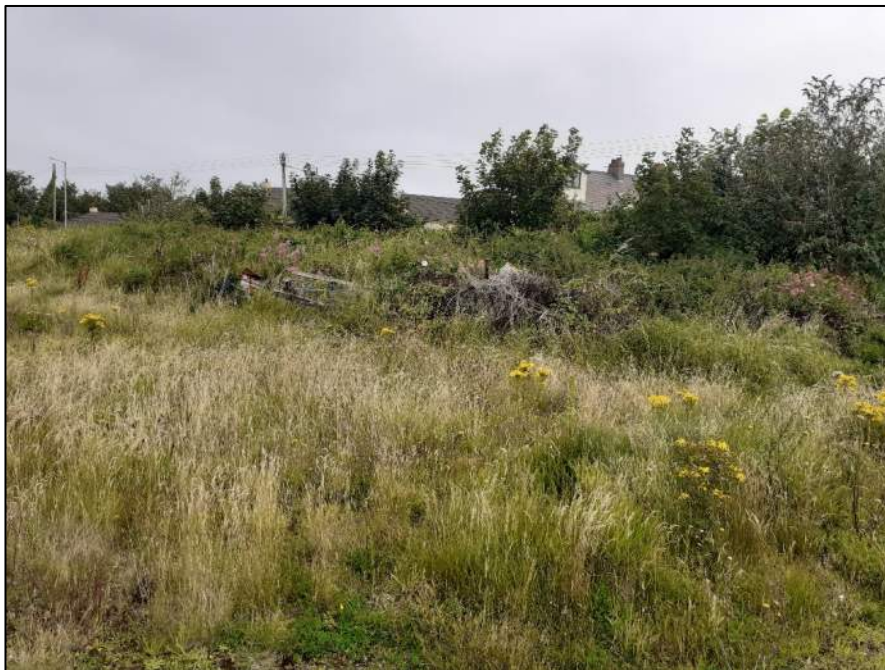
Raised vegetated bank in the east of the northern section of the site with some tipped demolition rubble.

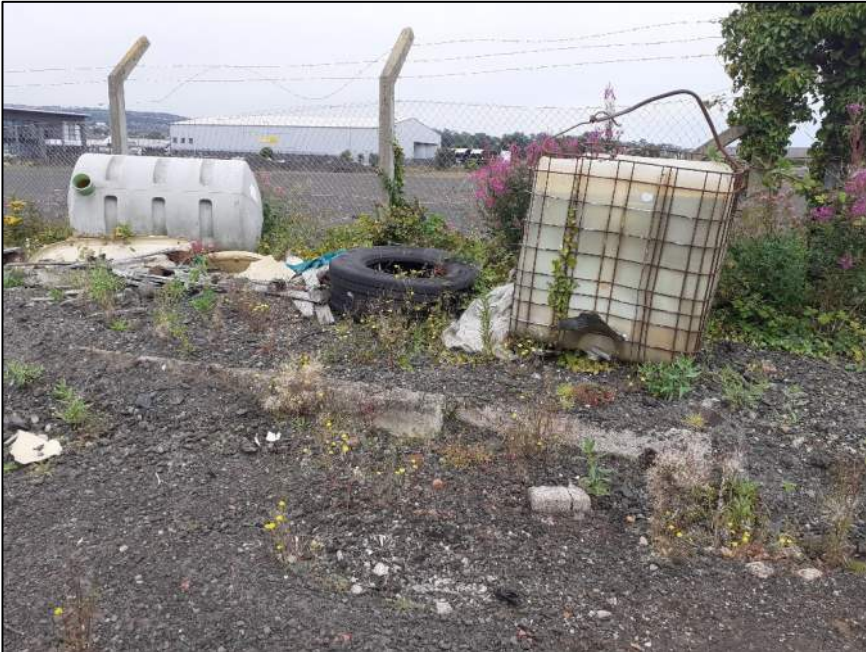
View of the redundant empty plastic tank and IBC filled with suspected rainwater at the boundary with the southern section of the site.

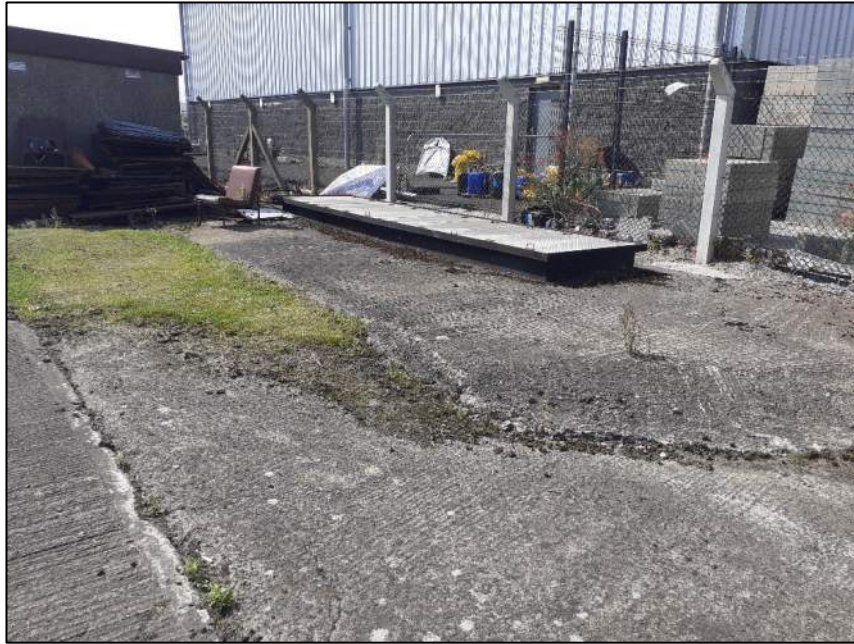
View of the cover over the Underground Storage Tanks (USTs) that capture the washings from the lairage.

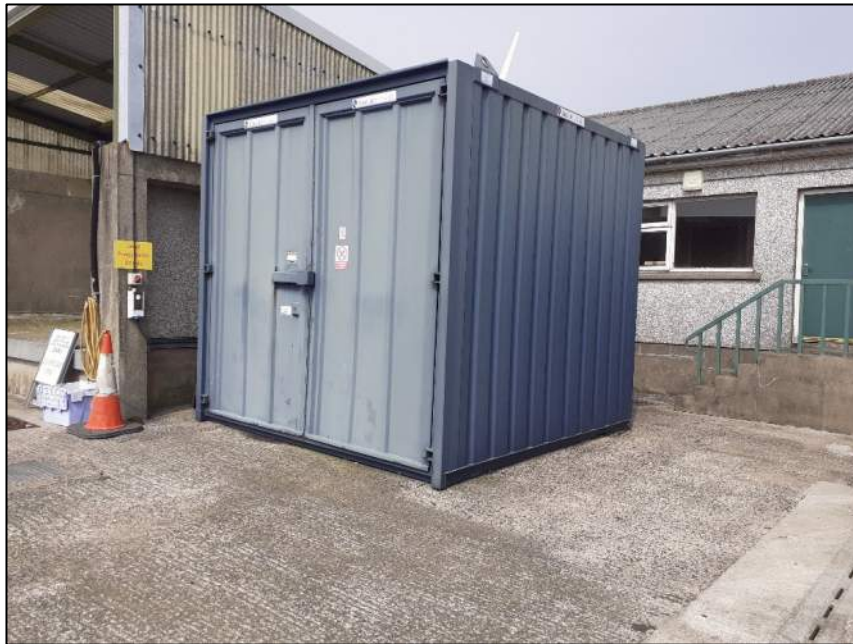
One large diesel oil tank and pump, c.10 years old, is present within a metal container, at the DAERA site to the front of the lairage building, with moderate staining observed on the concrete ground by the pump and tanks.

View of diesel tank and pump in container beside lairage.

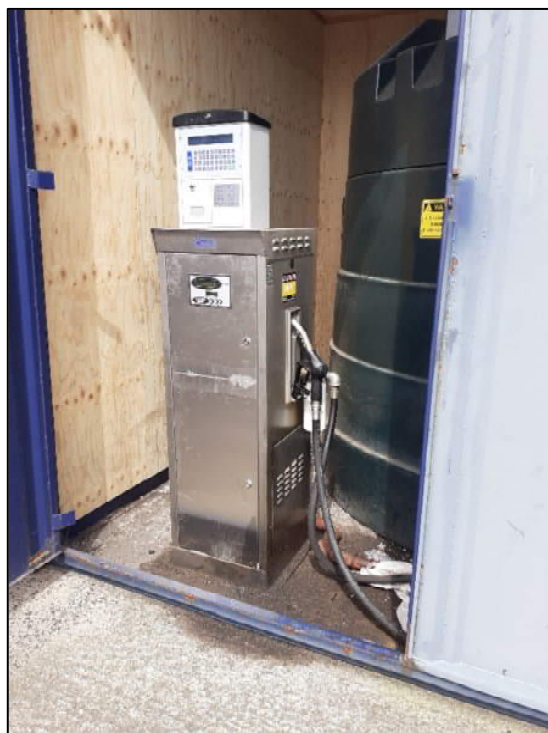
It is therefore anticipated that there is the potential for spills and leaks to have resulted from the storage of fuels and oils, potentially impacting shallow soils and groundwater in these areas.

View of diesel tank and pump inside container with staining on ground.

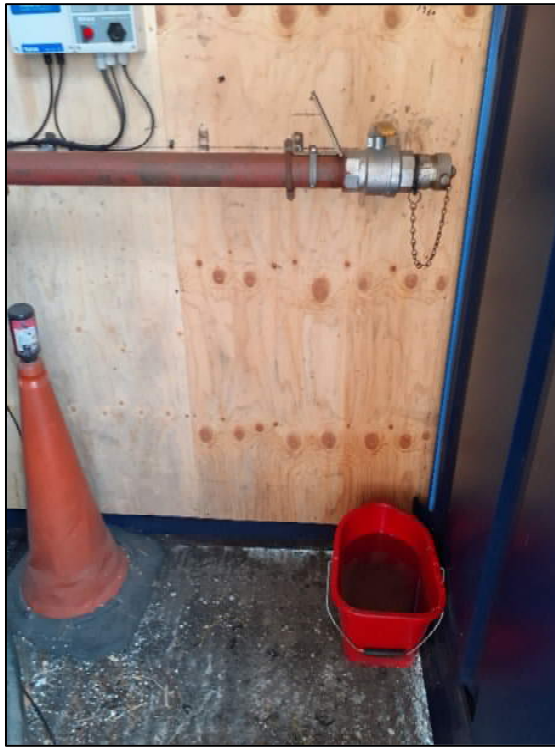
View of diesel tank fill point pipe and spill bucket below.

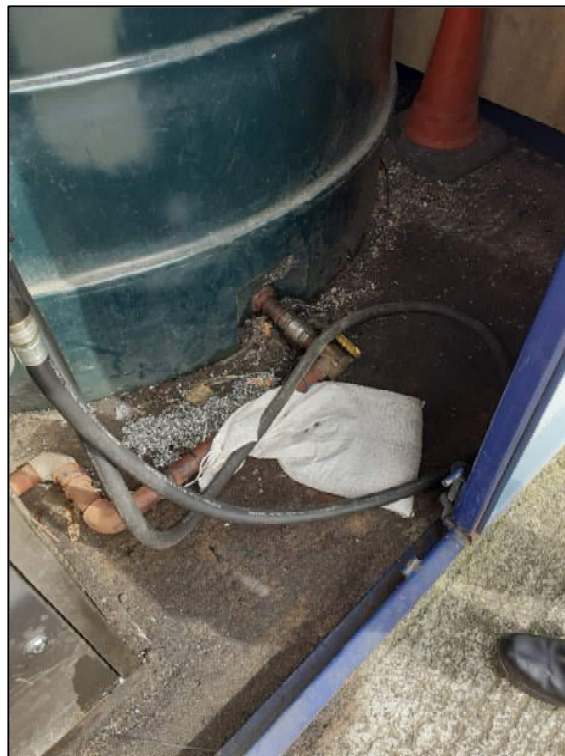
View of hydrocarbon staining on ground by the fuel pump fill point and connecting pipework.
