Oral Presentation by Newry & Mourne DC  
To Agriculture and Rural Development Committee  
25 February 2014  
The Reservoir Bill

### **Summary of Main Points - The Committee for Agriculture and Rural Development on the Reservoirs Bill**

## **Camlough Dam**

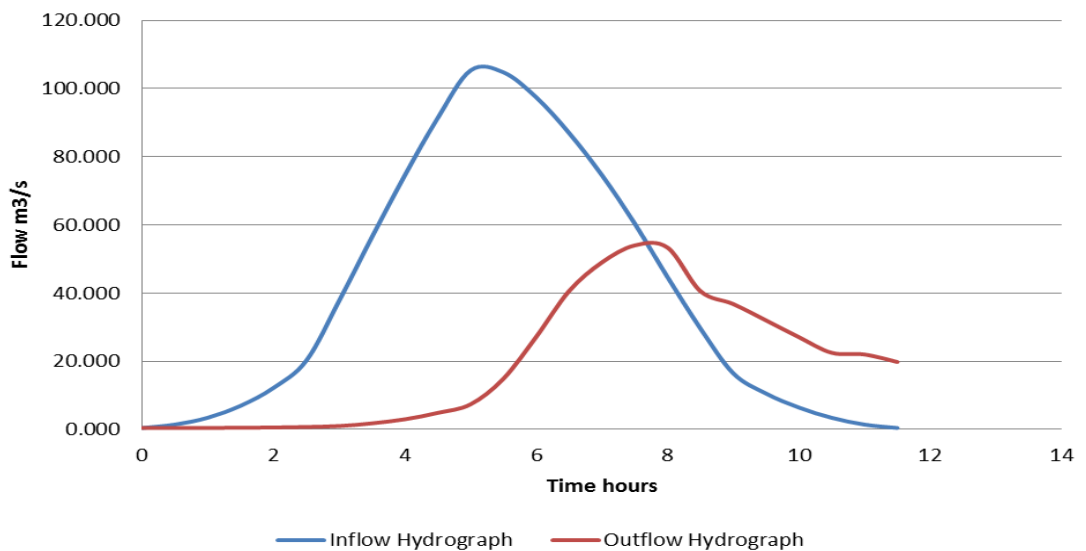
**Figure 4: Inflow and Outflow Hydrographs**

The Section 10 report also assessed the attenuation effect on the design inflow hydrograph which reduces the peak flood flow and creates a lag effect on the time of the peak. The reservoir routing exercise quantified this attenuation effect and the associated spillway discharge hydrograph for the design inflow reducing the peak inflow from 105m<sup>3</sup>/s to an outflow of 52m<sup>3</sup>/s. Such a large effect is predominately due to the large surface area of the reservoir, which creates a large flood storage volume. The inflow and outflow hydrographs for the existing spillweir arrangement are shown in Figure 4.

An assessment of the freeboard highlights that the existing 22.5m long spillweir and the 3m wide spillway channel, cannot discharge the PMF flow without overtopping the crest of the dam. Camlough Reservoir therefore does not comply with the requirements of the FRS guidelines and cannot safely pass the design flood through the reservoir without risk of damage to the dam.

The design outflow is 52m<sup>3</sup>/s but the existing spillweir/spillway arrangement can only discharge around 10m<sup>3</sup>/s without overtopping the crest. Therefore overtopping will occur on a structure not capable of sustaining overtopping flows. Accordingly, based on the dam categorisation of 'Category A', the existing spillweir is insufficient in discharging the design flow. Additional spilling capacity is therefore required in order to meet the current recommended safety standards.

There are several combinations of weir width and increased head which will achieve the desired result but our preliminary analysis has shown that the balanced solution to remedy the existing deficiency in the spillway capacity is to raise the dam crest by 0.3m and to provide a wave wall on the crest to protect against the design wave run up. The increase in hydraulic head on the existing spillweir will enable it to safely discharge the Probable Maximum Flood after attenuation and to satisfy the current safety standards for a reservoir with this level of consequence.
