AQW 10021/17-22 – INFORMATION TO BE PLACED IN THE ASSEMBLY LIBRARY

ARCHAEOLOGICAL EVALUATION & BRIDGE
CORING

AT
BELFAST TRANSPORT HUB

5 CORING OF SALTWATER BRIDGE, SANDY ROW BELFAST

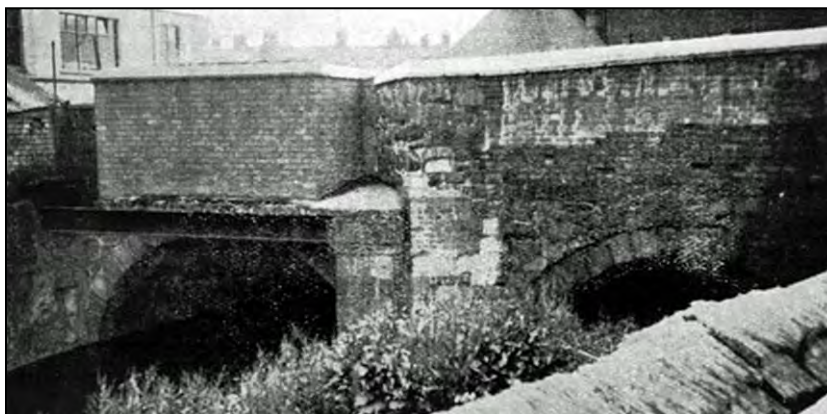
Fig.6: View of east face of Salt-water Bridge, c.1934 (Millin, 1938).

A photograph taken around that time shows the Saltwater Bridge's east (downstream) face (fig.6). It also shows the downstream face of the main archway (at left in the photograph) had been extended outwards from its original line to accommodate an open brick urinal, the floor of which was carried on metal girders between the abutment and pier.

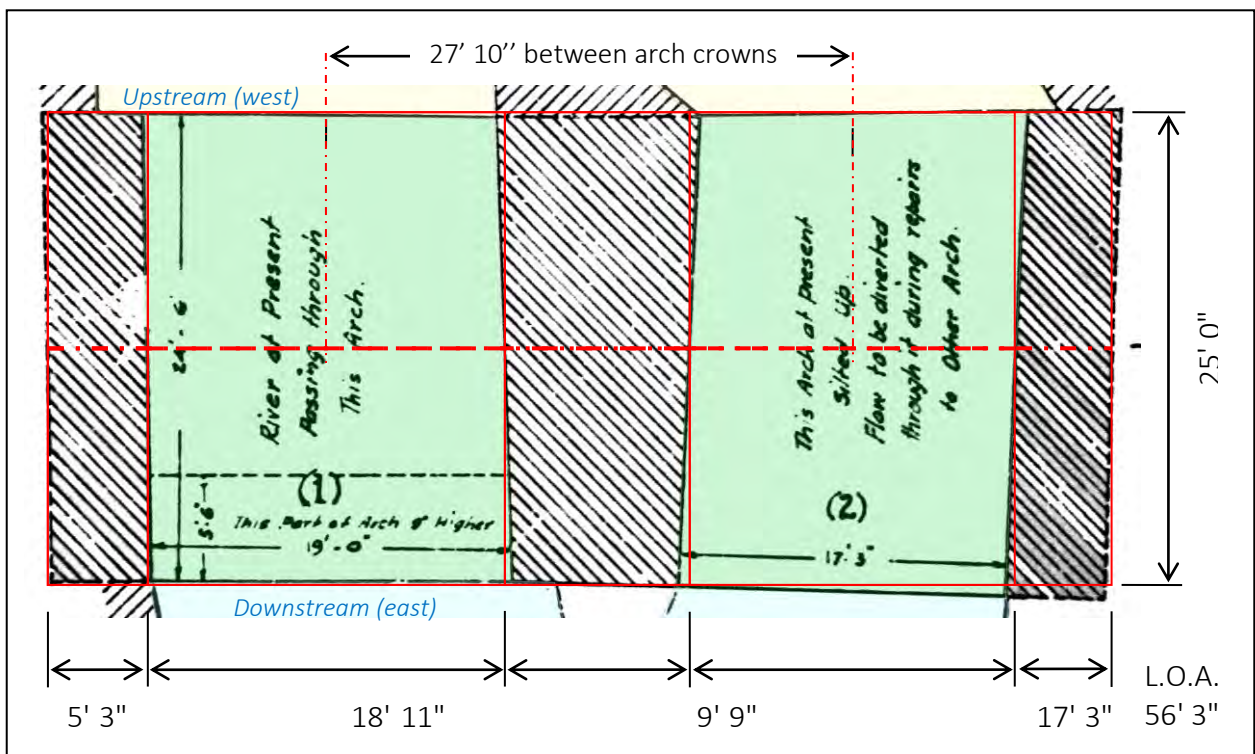
A 1936 drawing of the bridge shows the two semicircular arches of approximately the same height but slightly different widths (fig.7). The south arch spanned 19ft 0in (5.8m) and the north one 17ft 3in (5.3m) and both were 24ft 6in (7.5m) deep. Their rings were 14-inch (36cm) thick, but the exact profiles of their outer surfaces was uncertain.

The size and profile of the two arches was recorded in the 1936 drawings (fig.7 above). It should be noted that only the inside profiles of the two arches, the thicknesses of their crowns, the width of the pier between them, and bed level of the channel are depicted with certainty in these drawings. The widths and heights of the abutments and profile of the arches' outer surfaces are all conjectural. These profiles can then be superimposed on the five Causeway Geotech core profiles in order to gauge the depths of their crowns below the present road surface. There are three possible scenarios:

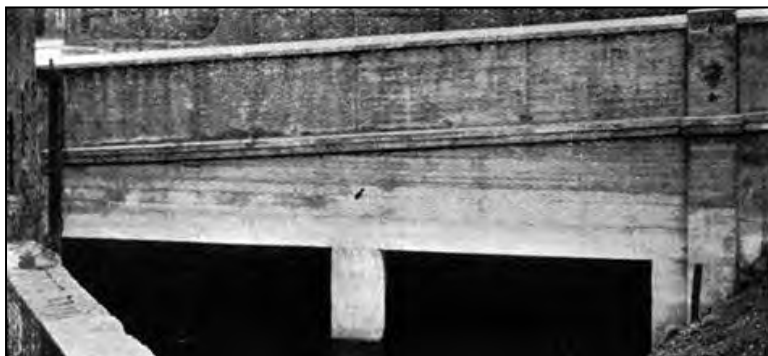
Fig.8 Photograph of widened downstream elevation of Saltwater Bridge, 1936 (Millin 1938).

ones. The eastern face of the bridge was also widened with two reinforced-concrete beam-and-slab spans supported on concrete abutments and piers to give a straight run for the new 60ft wide Boyne Bridge (fig.8).

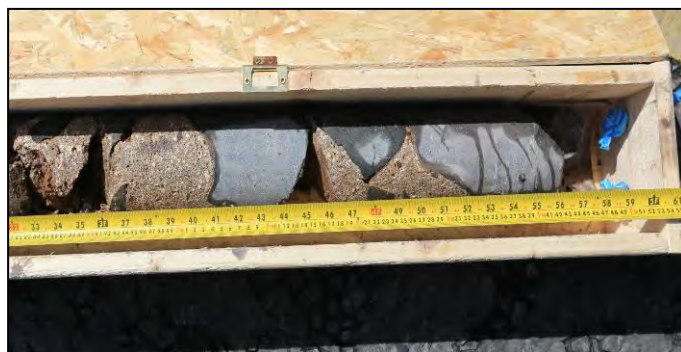
Fig.15 Basalt - gunite plug at bottom of core 1.

A second core was taken, between 300 and 450cm below the surface. In contrast to the first one, it contained looser material, much of which was missing; the recovery rate was only c.50%. What remained mostly comprised fragments of basalt and gunite. One of the latter pieces was 8cm thick and had a piece of steel embedded in its matrix. Its bottom surface was also steeply angled and appears to be a finished face. Several fragments of gunite were also recovered from the bottom of the second core.

The low recovery rate from the second core suggests that it missed the abutment but, rather, continued through into the void underneath the arch. Whatever loose material was inside this void had mostly been washed away. The gunite found in this core possibly derives from a build-up on the bed of the channel as the arch was being sprayed.

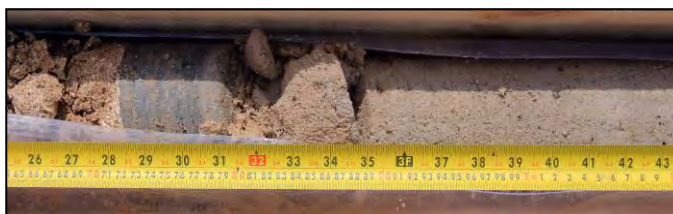
Fig.16 Gunite horizons at bottom of core 2.

The upper part of the core comprised gravel and clay similar to that in core 1. Again, there was considerable wash-out of the finer material so it is difficult to ascertain its actual thickness. It overlays a layer of basalt fragments interspersed with gunite. Below it is a 10cm thick horizon of layered gunite and then uniform gunite down to a depth of 300cm (fig.16).

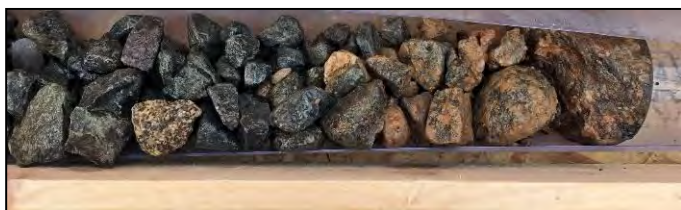
Fig.17 Washed out gravel in core 3.

The recovery rate for the core below the road deck was only 27% and comprised mostly fragments of medium-sized gravel from which the finer material had evidently been washed out (fig.17). There were also some fragments of basalt with lime mortar attached, but their precise depths could not be ascertained due to the wash-out.

The second core, between 300cm and 450cm contained a 40cm thick lens of basalt but its precise depth is uncertain due to the wash-out of material from above and below it. As before, the low recovery rate indicates that the core had largely cut down through natural sand and gravel. Interestingly, no gunite whatsoever was observed.

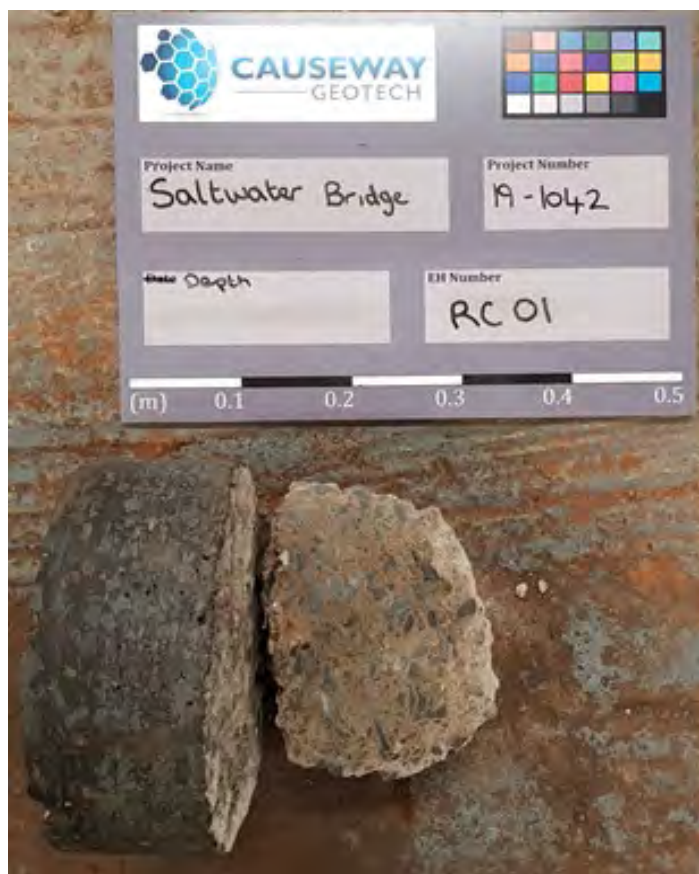
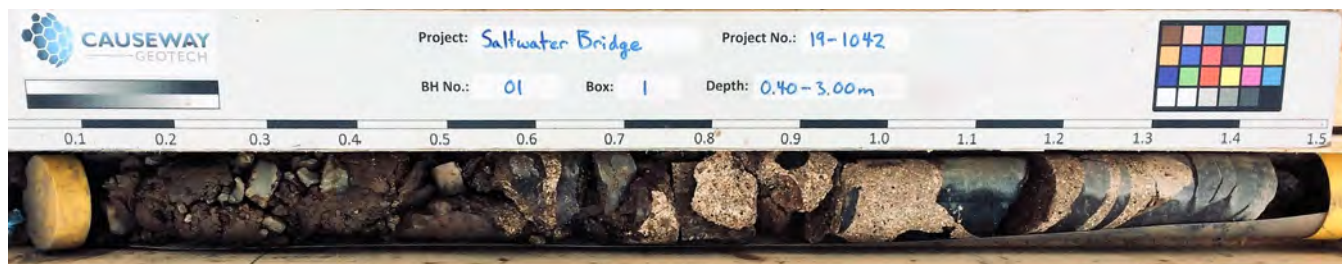
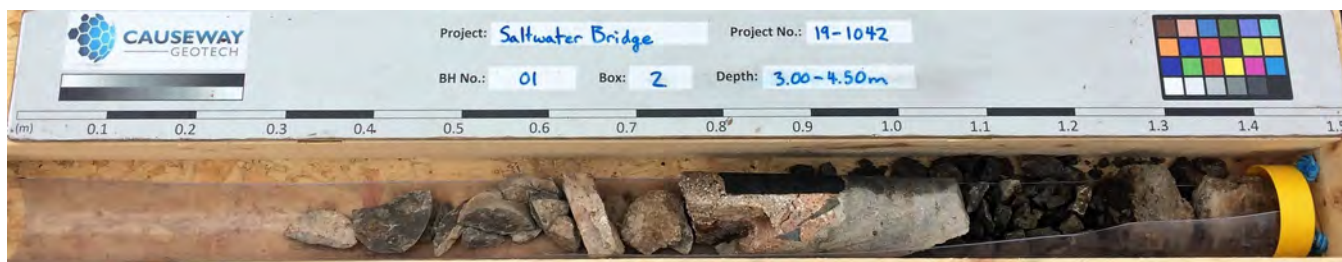
Road Core -RC01

Layer	Depth (mm)	Thickn ess (mm)	Description
1	0 - 45	45	Strong dark bluish grey and black BITMAC with coated chippings and high binder content. 40-50% subangular 1-13mm aggregate with <1% small voids. Positive textured surface.
2	45 - 110	65	Strong dark bluish grey and black BITMAC with low binder content. 75-85% subangular 0-10mm aggregate with 2% small to medium voids.
3	110 - 290	180	Strong dark grey and light brown CEMENT with high binder content. 40-50% subangular 1-13mm aggregate with 1% small voids.

RC01 Box 1 - 0.40 - 3.00m

RC01 Box 2 - 3.00 - 4.50m

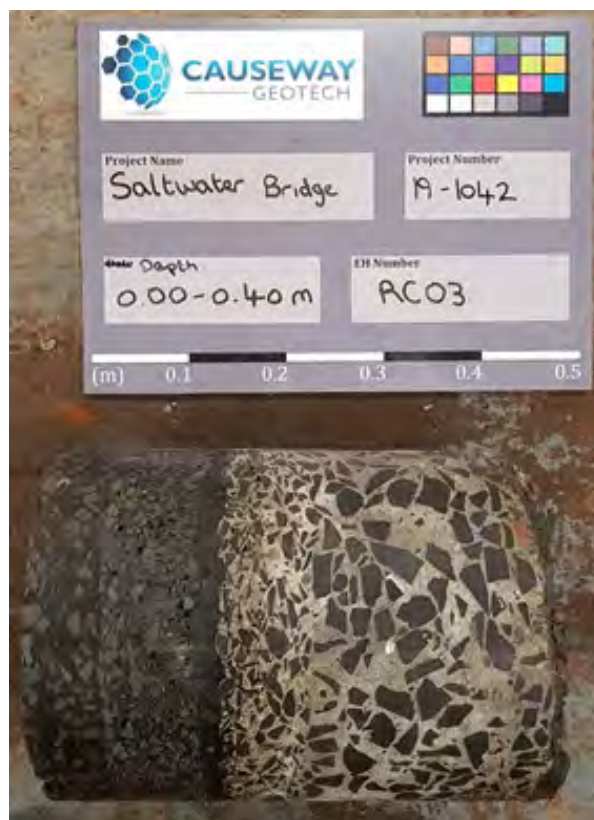
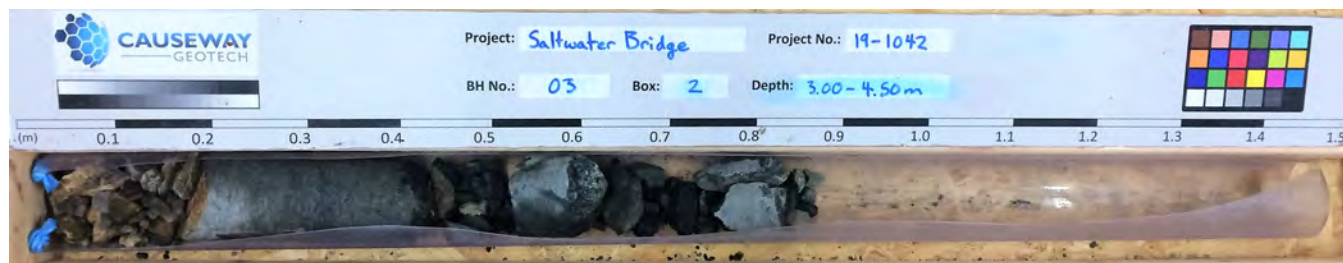
Road Core -RC03

Layer	Depth (mm)	Thickness (mm)	Description
1	0 – 55	55	Strong dark bluish grey and black BITMAC with coated chippings and high binder content. 40-50% subangular 1-14mm aggregate with no voids. Positive textured surface.
2	55 – 123	68	Strong dark bluish grey and black BITMAC with low binder content. 75-85% subangular 0-10mm aggregate with 10% small to large voids.
3	123 – 140	17	Strong very dark grey and black BITMAC with high binder content. 40-50% subangular 1-11mm aggregate with no voids.
4	140 – 195	55	Strong very dark grey and light brown CEMENT with medium binder content. 65-75% subangular 0-12mm aggregate with 5% small to large voids.
5	195 – 400	205	Strong very dark grey and light brown CEMENT with high binder content. 40-50% subangular 1-25mm aggregate with 1% small to medium voids.

RC03 Box 1 – 0.40 - 3.00m

RC03 Box 1 – 3.00 - 4.50m

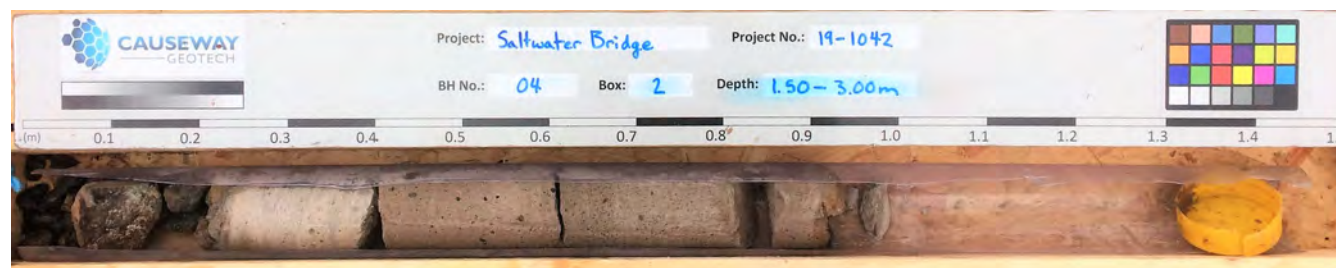
Road Core RC04

Layer	Depth (mm)	Thickness (mm)	Description
1	0 - 60	60	Strong dark bluish grey and black BITMAC with coated chippings and high binder content. 40-50% subangular 1-17mm aggregate with no voids. Positive textured surface.
2	60 - 130	70	Strong dark bluish grey and black BITMAC with low binder content. 75-85% subangular 0-10mm aggregate with 2% small to large voids.
3	130 - 220	90	Strong very dark grey and light brown CEMENT with medium binder content. 65-75% subangular 0-10mm aggregate with 5% small voids.
4	220 - 400	180	Strong very dark grey and light brown CEMENT with high binder content. 40-50% subangular 1-22mm aggregate with 1% small to medium voids.

RC04 Box 1 - 0.40 - 1.50m

RC04 Box 2 - 1.50 - 3.00m

NO RECOVERY (Sands & Gravels)

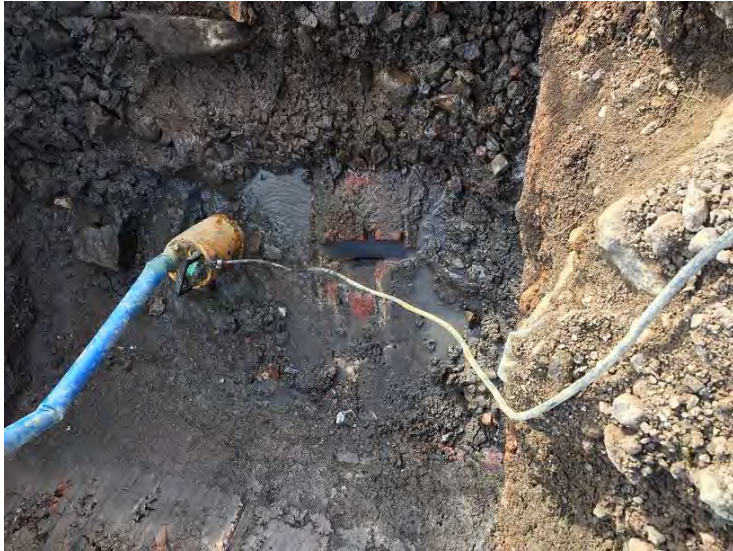
Plate 5 Trench 3, brick drain C14, facing southwest.

Towards the southwest end of Trench 3, a red brick drain (C14) was identified at a depth of 1.6m (Plate 5). The drain measured 0.3m in width and was orientated northwest–southeast. Its depth was unknown as it contained a reservoir of water that repeatedly filled the base of the trench. The brick appeared to be of the same type recovered from Trenches 1 & 2 and it is likely to be a feature contemporary to the other archaeological activity noted on site.

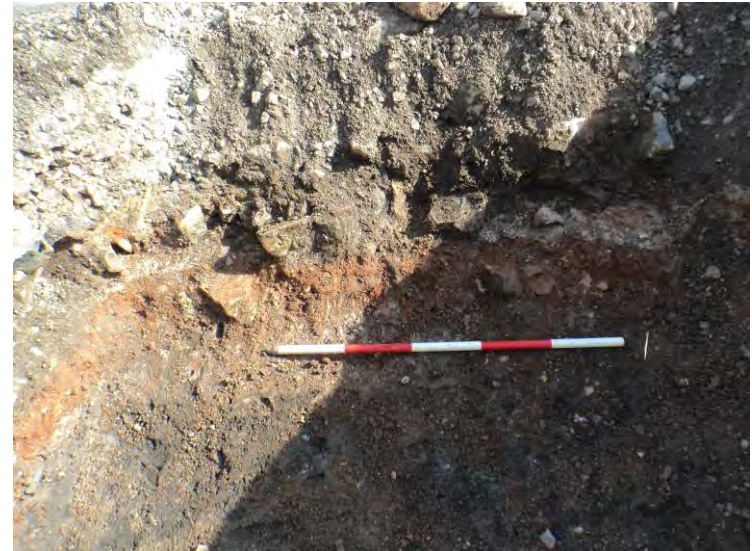
Plate 6 Trench 3, Possible sandstone wall C7, facing southeast

A possible wall foundation (C7) was identified at the southeastern end of Trench 3 at a depth of 0.46–0.88m (Plate 6). The feature was composed of mortared sandstone with degraded sandstone around the edges. Beneath was a deposit of mortar with brick fragments contained within a matrix of fine grained dark grey silty clay. This feature was preserved *in situ* and covered with a layer of geotextile (terram) before the trench was backfilled. A large piece of struck flint was recovered in association with the wall.

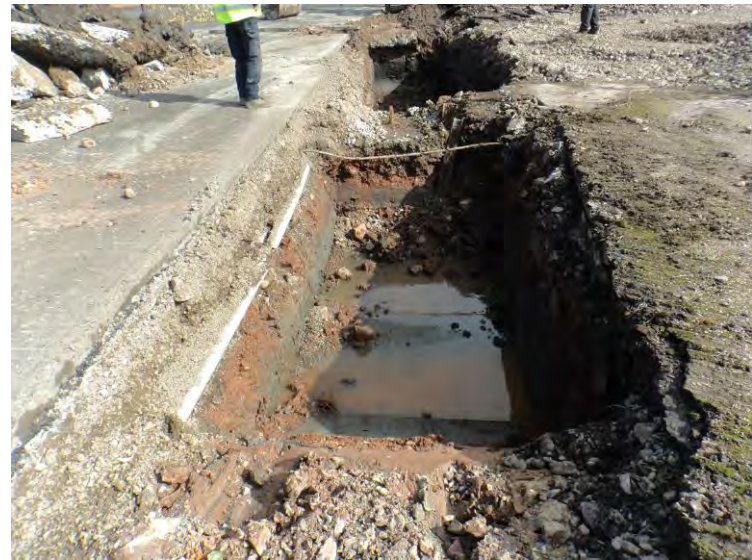
Plate 8 Trench 5, plastic ducting visible, facing northeast.

In Trench 5, beneath the hardcore, a surface of large rounded cobbles and square sets was present. Along the northern trench face two grey plastic pipes were encountered, one of which was damaged (Plate 8). Although some water flowed out of the pipe it was not pressurised and dissipated very quickly. At the northeastern end a ceramic drain and metal pipe were encountered at a depth of 1.2m. These same pipes and plastic ducting were also encountered during the excavation of Trench 6.

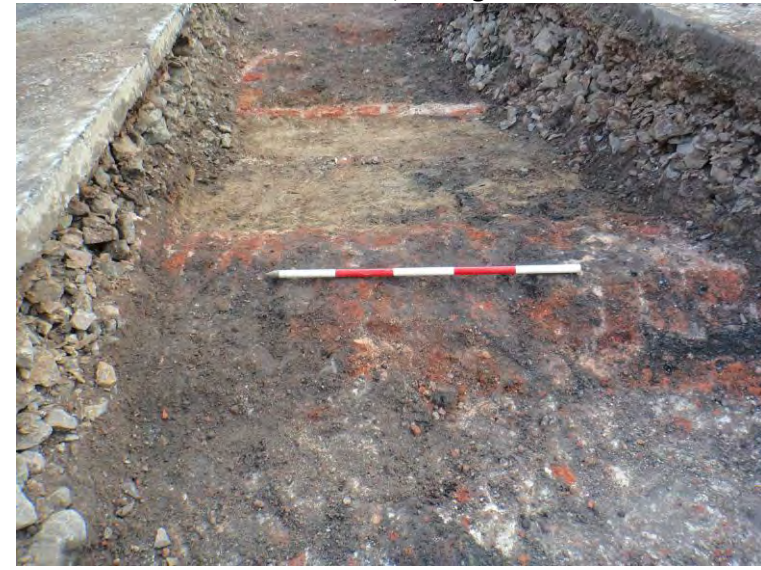
Plate 12 Trench 7, brick wall C10 (foreground), facing northeast.

Northeast of this, c. 11m from the southwest edge of trench, was wall (C10). Between C9 and C10 was a spread of degraded mortar rubble with numerous brick inclusions. C10 was orientated south–north through the trench at a depth of 0.58m and measured 2m in length and 0.65m in width (Plate 12).

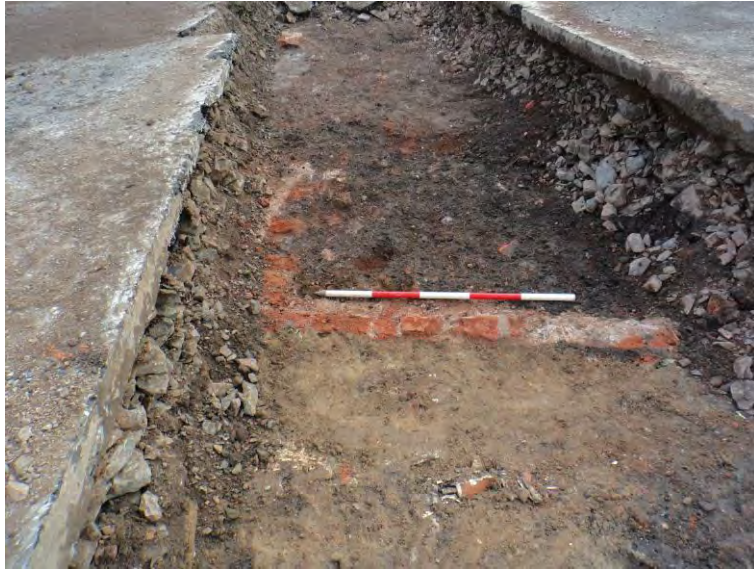
Plate 13 Trench 7, brick walls C11 and C33, facing northeast.

Northeast of C10 was a spread of yellow sand with a ceramic drain running north–south between C10 and brick wall C11. C11 was located c. 13.2m from the southwest edge of trench. It was orientated south–north and was located at a depth of 0.58m. It measured 1.5m in length and 0.13m in width. Brick wall (C13) abutted C11 at its northern end (Plate 13). It measured 1.7m in length and 0.2m in width, widening to 0.45m at the east. Demolition deposits were noted to the northeast of C11.
