Oral Presentation by Newry & Mourne DC  
To Agriculture and Rural Development Committee  
25 February 2014  
The Reservoir Bill

### **Summary of Main Points - The Committee for Agriculture and Rural Development on the Reservoirs Bill**

## **Camlough Dam**

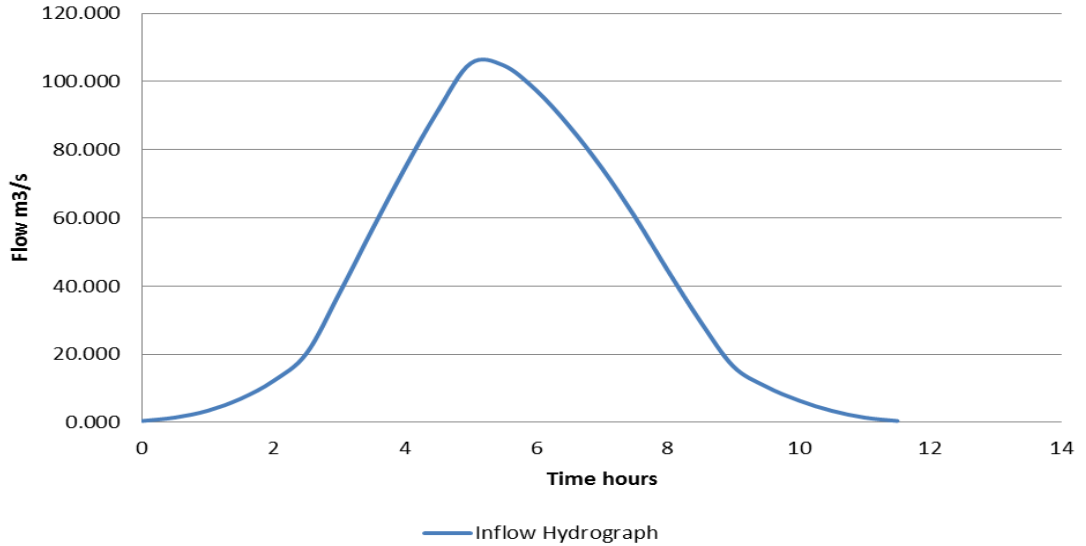
**Figure 3: Inflow Hydrograph**

The Section 10 Report has demonstrated that the PMF design flood inflow, assessed using the Hydrograph method from the 1975 Flood Studies Report (FSR), has a peak inflow of 105m<sup>3</sup>/s, refer to Figure 3 for the associated hydrograph.

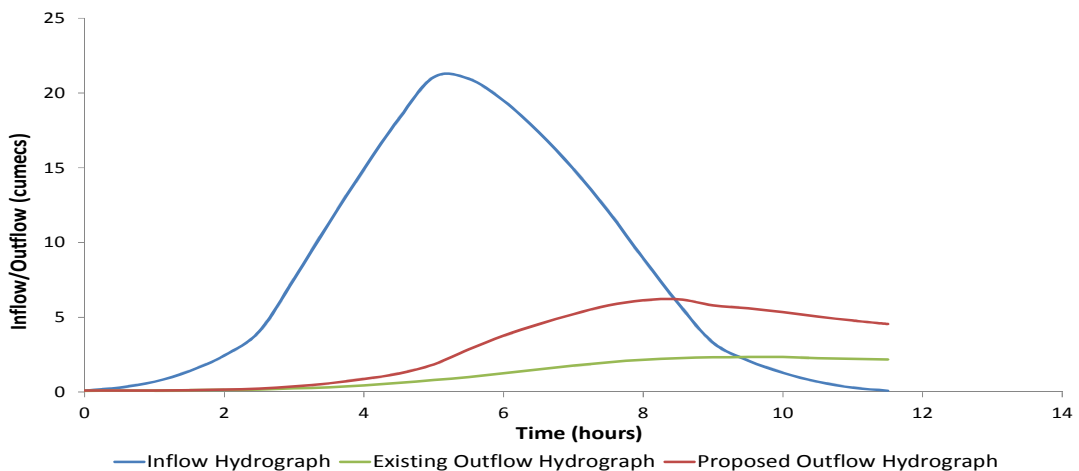
The abandonment report includes a detailed assessment of the hydraulic impact of abandoning the reservoir in relation to downstream flood risk. It demonstrates that following removal of the impoundment, the Q150 outflow from the lake will be 6.2m<sup>3</sup>/s. (based on flow being discharged through a trapezoidal channel, 5.0m wide at the base and with 2H: 1V side slopes following abandonment). This is a 265% increase in the current Q150 outflow of 2.3<sup>3</sup>/s. Figure 6 below shows the Q150 inflow hydrograph for the reservoir, the Q150 outflow hydrograph for the current condition and the Q150 hydrograph for the new outlet channel.

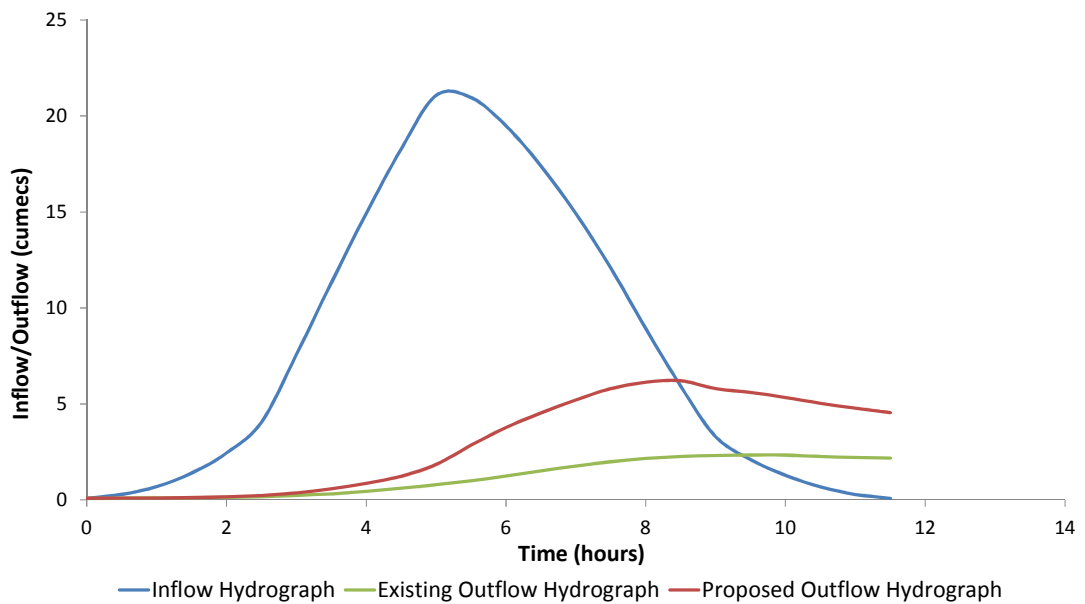
**Figure 2 Q150 Inflow and Outflow Hydrographs**

Following removal of the impoundment, it is estimated that the Q150 outflow from the lake will be 6.2m<sup>3</sup>/s. This is based on flow being discharged through a trapezoidal channel, 5.0m wide at the base and with 2H: 1V side slopes following abandonment. This is 265% greater than the current Q150 outflow of 2.3<sup>3</sup>/s. The figure below shows the Q150 inflow hydrograph for the reservoir, the Q150 outflow hydrograph for the current condition and the Q150 hydrograph for the new outlet channel.

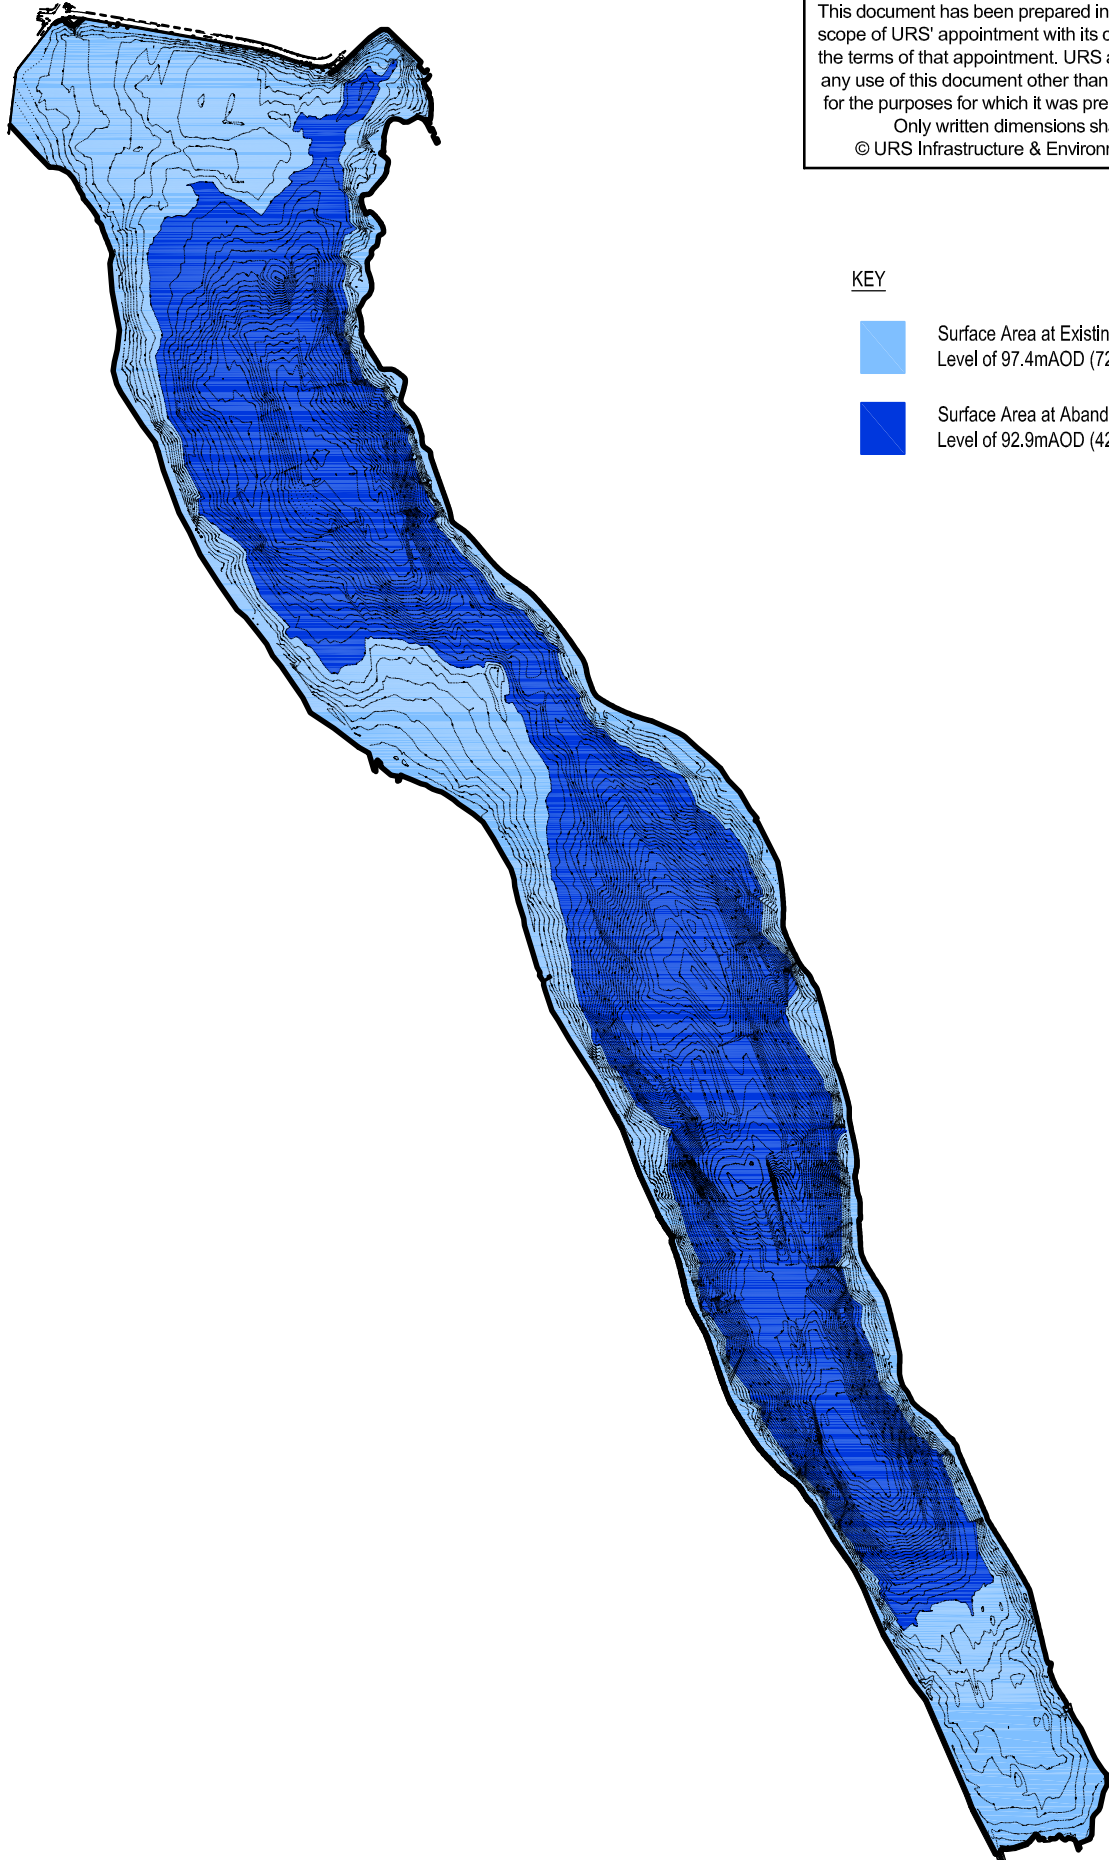
## **APPENDIX B CHANGE IN SURFACE AREA**

- Surface Area at Existing Top Water Level of 97.4m AOD (72ha)
- Surface Area at Abandoned Top Water Level of 92.9m AOD (42ha)
